**Report
on
High Energy Solar Spectroscopic
Imager (HESSI) Test Mishap**

***By the
HESSI Test
Mishap Investigation Board***

Released May 18, 2000

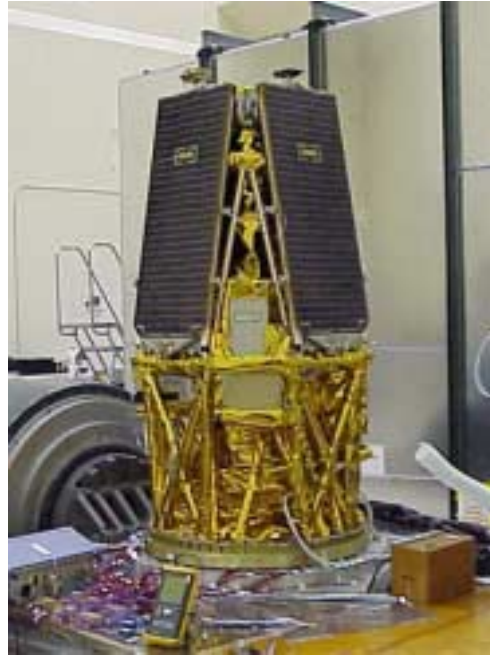
Figure 6-1

The HESSI spacecraft was mounted to an adapter ring that was then mounted to the magnesium alloy slip table via an aluminum fixture plate, as shown in Figure 6-1, in preparation for testing in the spacecraft's X direction. Twenty-four force gages were placed between the spacecraft adapter ring and the fixture plate at each of the attachment bolt locations to measure the force input to the spacecraft.

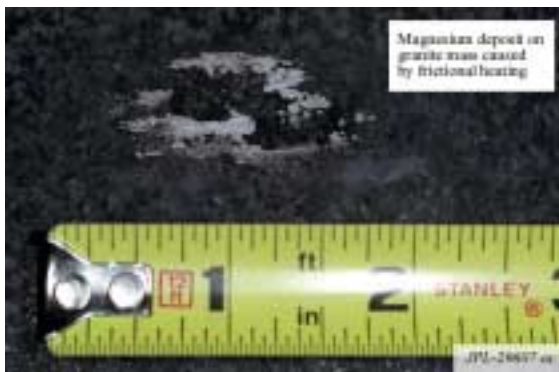
Subsequent disassembly of the shaker system by the JPL laboratory personnel revealed that the trunion support needle bearing on the north side of the shaker has a broken outer race and some of the rollers are loose and missing from the bearing housing. The 1", grade 8 bolts mentioned above are actually broken with the through holes for the fasteners being misaligned with the threaded holes by approximately ½ diameter of the fastener. The underside of the slip table is also damaged. The area of contact between

the slip table and the granite mass generated sufficient heat due to friction to cause the magnesium alloy material from the plate to deposit onto the granite mass, refer to Figure 7-1 below. The plate has an area of material loss that is consistent with the metallic deposit found on the granite mass, refer to Figure 7-2 below. The damage to the bottom of the slip table is not consistent with a shock event that has duration of only a few cycles. It is consistent with several minutes of operation during which heat would have continued to build in that local contact area. The slip table and granite would have to operate in a “rubbing” condition for sufficient time to build enough heat in that area to cause the deposit of the magnesium alloy onto the granite mass. It is evident that the material loss of the damaged area of the slip table is not simply the result of abrasion. Ample evidence has been detailed that shows the stiction condition was present throughout the day’s testing.

Recommendation: Refurbish or replace the Ling Model A-249 shaker.
